Health Consultation

MILL VIEW SUBDIVISION

PORT ST. JOE, GULF COUNTY, FLORIDA

OCTOBER 31, 2001

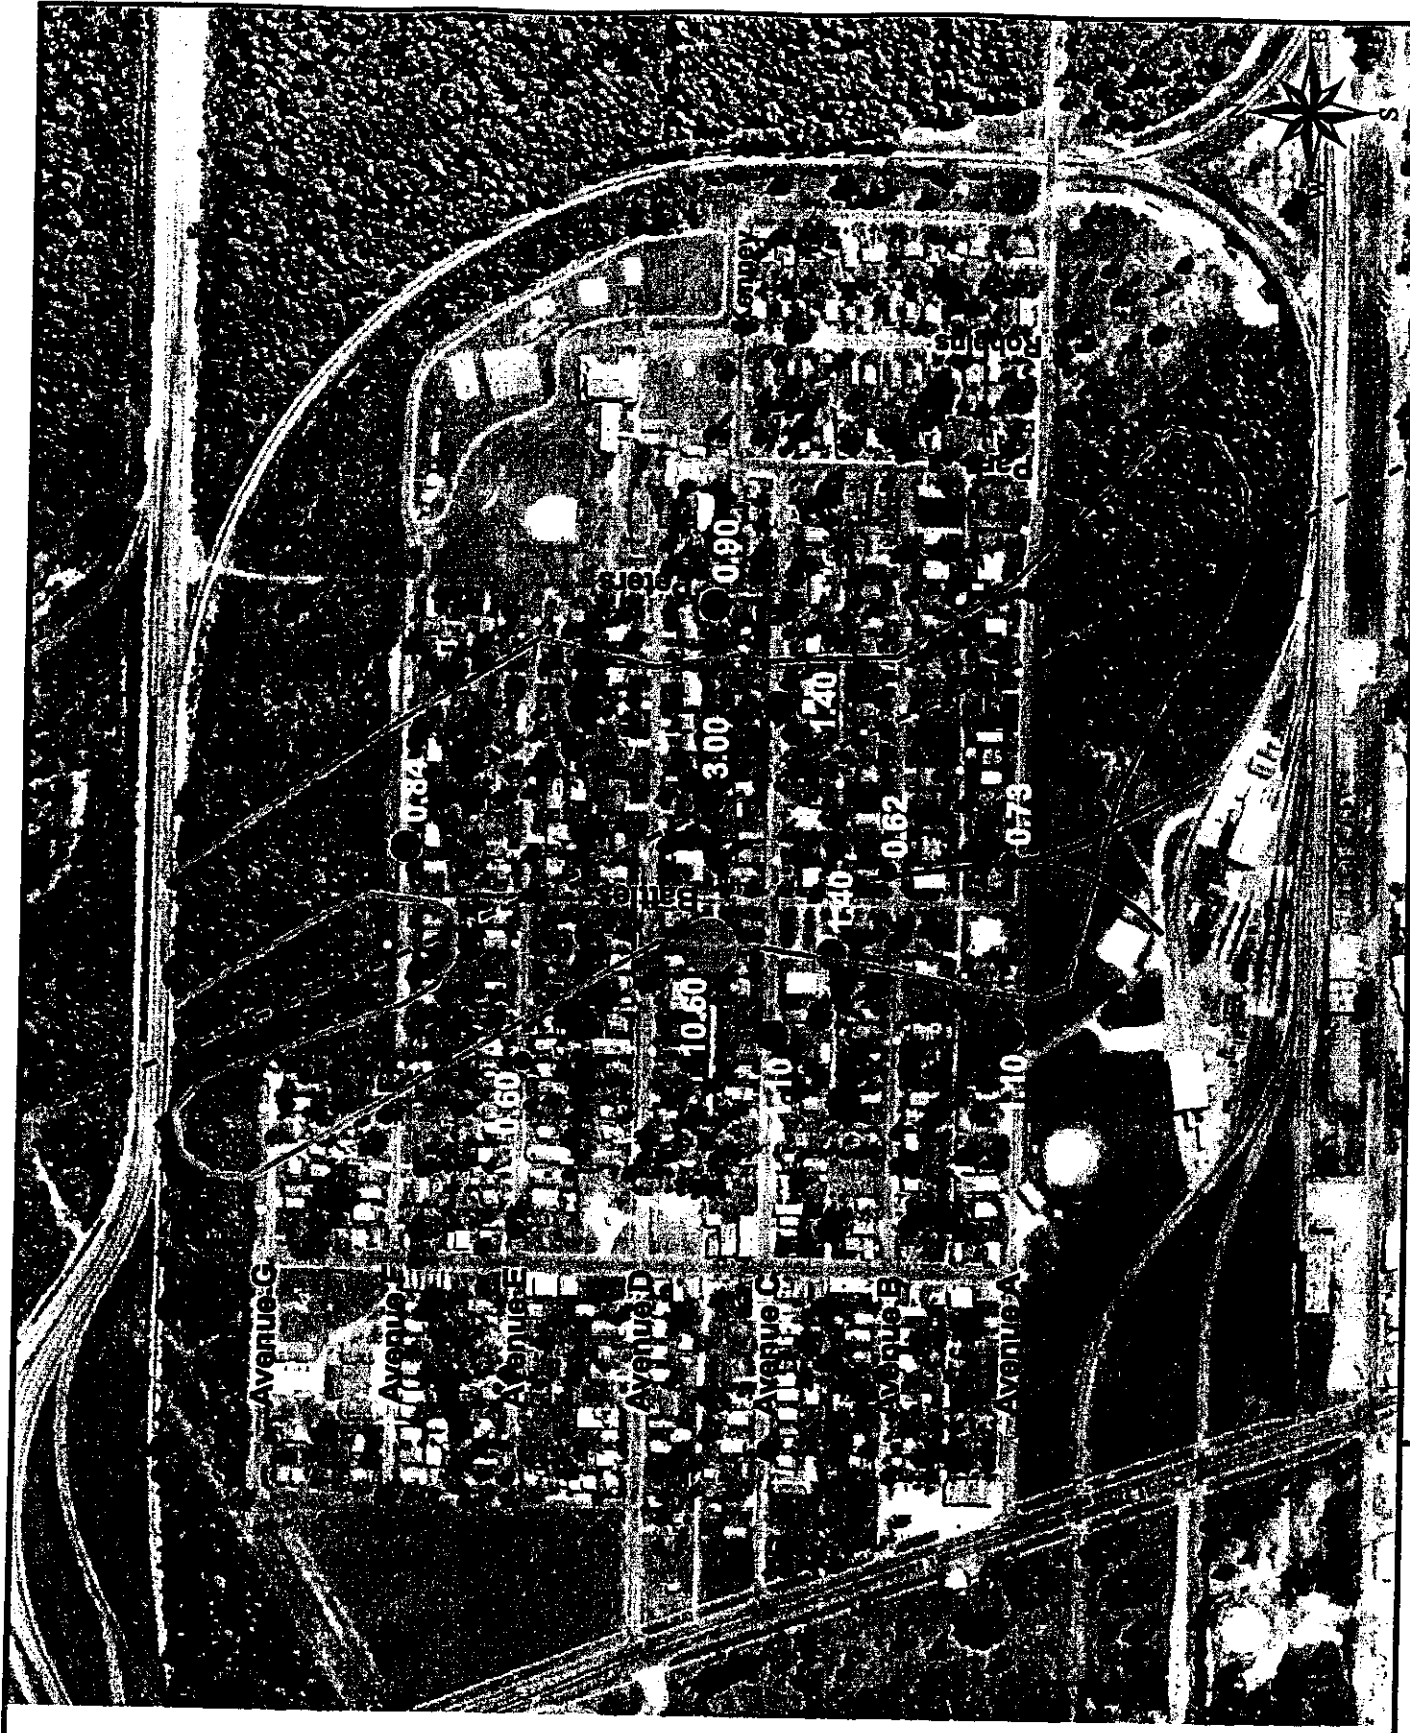
Figure 2 -
Information
from DEP

In 1938, the St. Joe Paper Company began paper mill operations in Port St. Joe, Florida on the Gulf of Mexico (Figure 1). From the 1940s to the early 1950s, the St. Joe Paper Company filled a wetlands west of the paper mill with paper mill wastes. These wastes included tree bark, boiler ash, "lime grits" and slag. In the mid-1950s St. Joe Paper Company created the 100-acre Mill View subdivision on top of some of the filled area (Figure 2).

The arsenic concentrations in soil (0-12 inches deep) at eight of the 32 locations were above ATSDR's cancer screening value. A one-in one million excess cancer is a governmental risk

**Arsenic in Shallow Soil Interval
Mill View Subdivision
Port St. Joe, Gulf County, Florida**
